ORNL/TM-8859

**Committee's Report on Ruthenium  
Fall-Out Incident**

Formerly issued as an internal report  
January 25, 1960

## REPORT OF THE COMMITTEE ON THE RUTHENIUM FALL-OUT INCIDENT

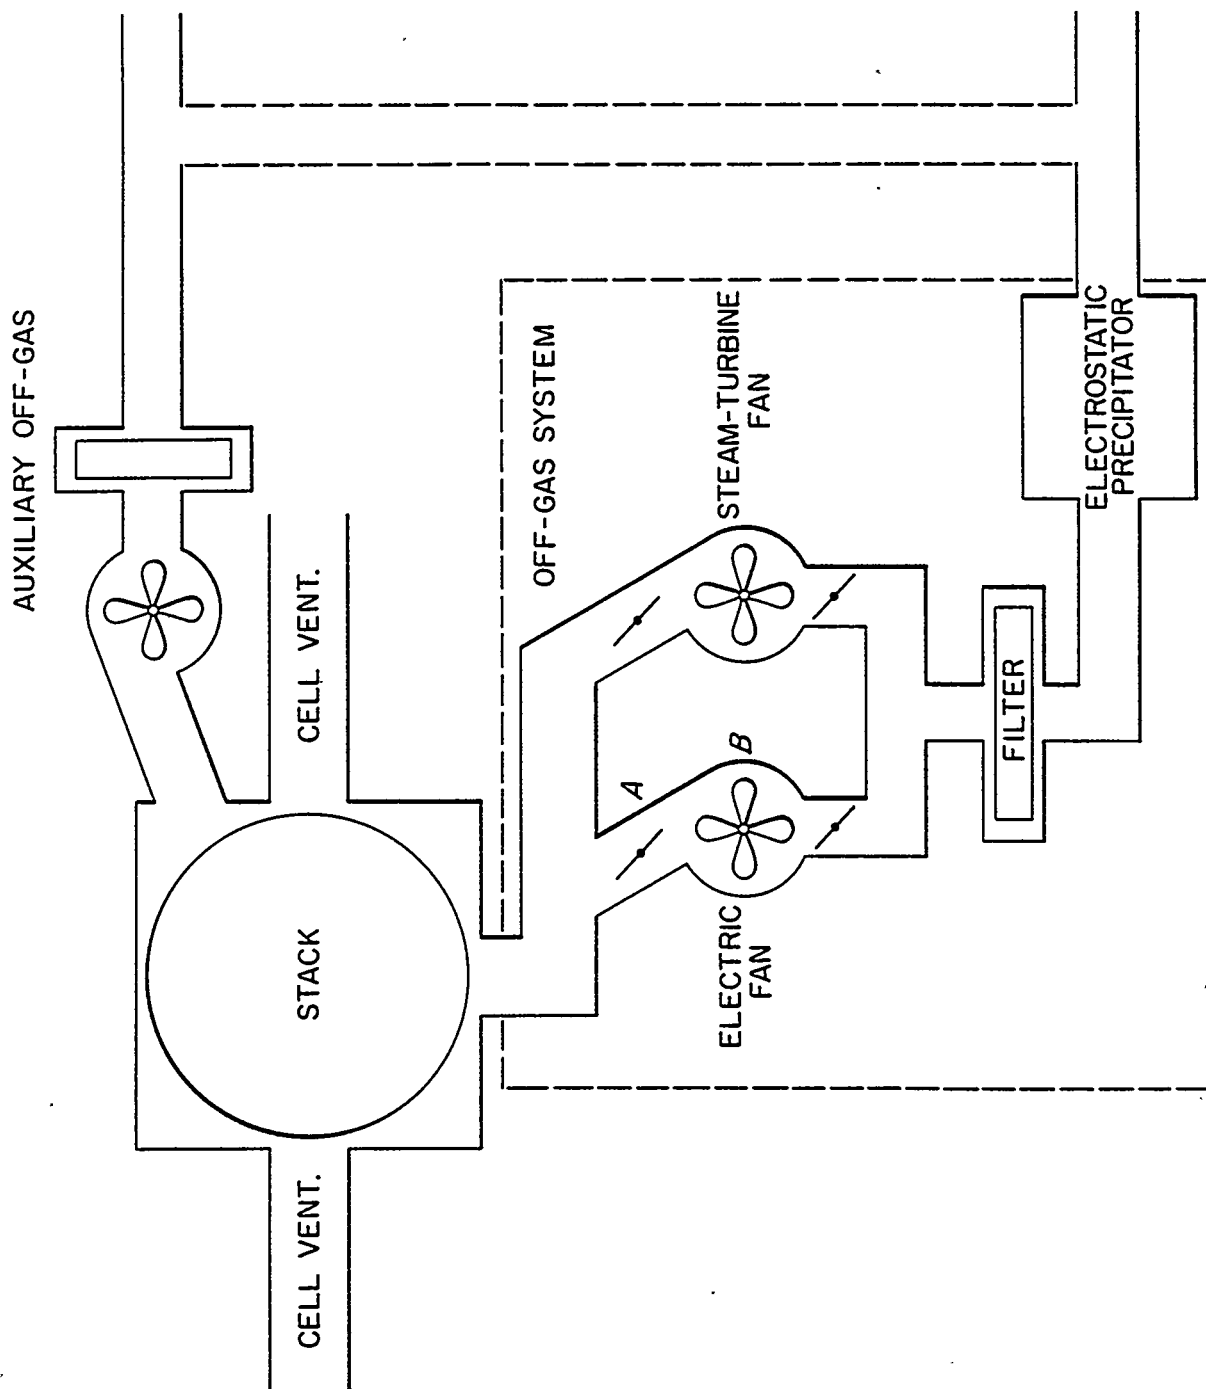
An appreciation of the physical layout of the gaseous waste disposal system associated with the brick stack is essential to an understanding of the circumstances leading to the incident. A schematic sketch of the off-gas system is shown in Fig. 1. The first element requiring maintenance was the exhaust damper or valve of the electric fan (indicated by A). The second maintenance problem was one of the bearings of the electric fan itself (indicated by B). Hence on two occasions there was opportunity for mechanical vibration and shock to detach particles on the duct walls of this fan. Not shown on the diagram (Fig. 1) is the stack monitoring arrangement. This consists of a gas stream collected from 40 feet above ground level in the stack and conducted by a small diameter pipe ( $\sim 1$  to  $1\frac{1}{2}$ " diameter) to a collection filter located near ground level. The filter is normally checked daily. An experimental filter-monitor, checked weekly, has been attached to this same sample line during the past several months.
